Improving the tailgate lock

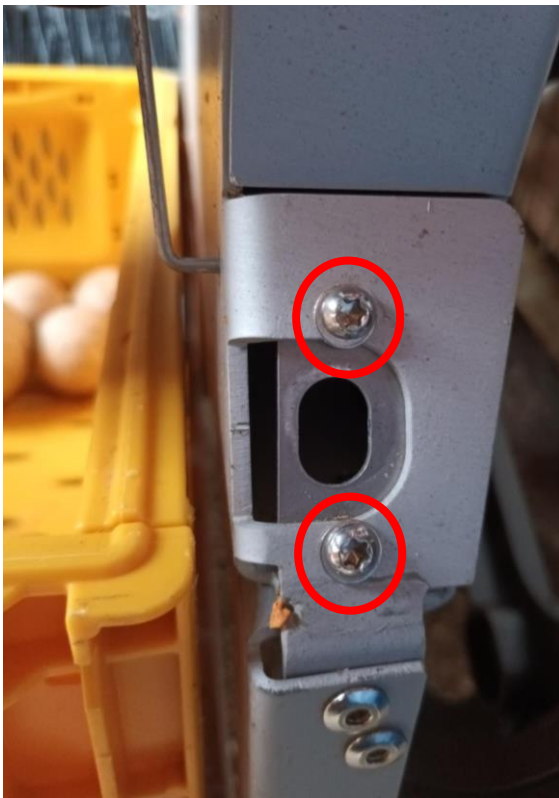
1. Remove the right wheel of your machine.
2. Unscrew the right-hand side cover - it is best to open the 6 Torx screws by hand (these are stainless steel threads that rub easily).
3. Now you can unscrew the counterpart of the lock, the plate with the oval opening. To do this, loosen the two screws marked in red and hold the nut on the back.

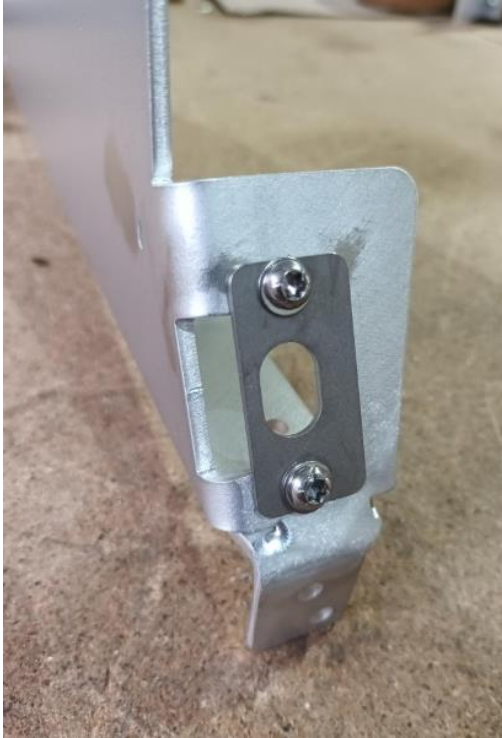
4. The panel must now be mounted in the same place, but on the outside of the aluminium frame. Use the same screws, washers and nuts for this. The narrow vertical bar of the plate is on the inside, the wider bar to the right of the oval is on the outside.

5. Now try to close the tailgate several times. The pin of the catch with the spring must be exactly centred in the oval. If this is not the case, you can move the locking plate with its oval cut-out sidewise before fixing it in place.
6. The side cover and the wheel can be refitted. When fitting the side cover, please ensure that the 6 Torx screws do not rub. This can be prevented by applying a drop of oil to the screw and tightening by hand.
